BUILT TO PROTECT

Flood Resilience

Designing for Flood Resilience and Resistance

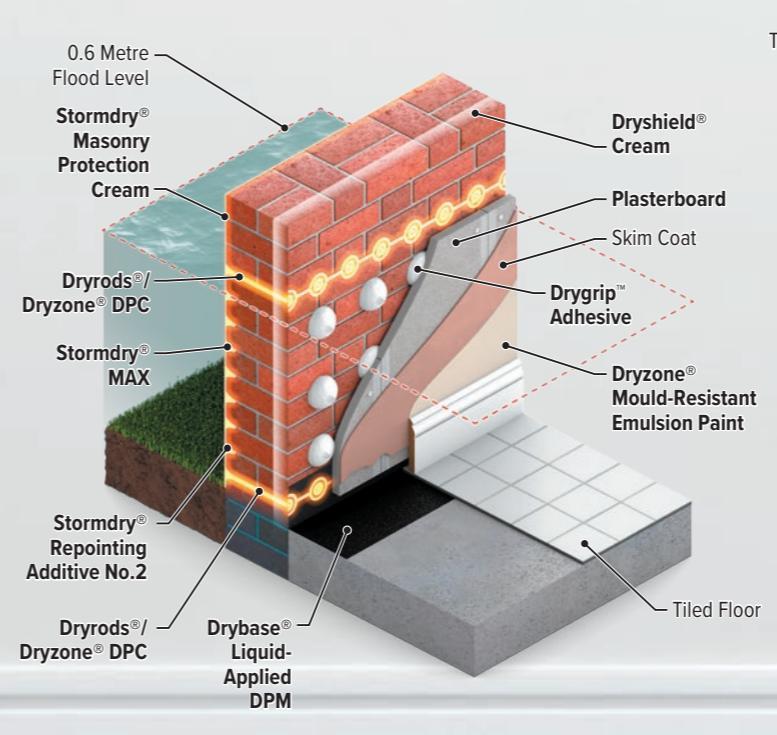
This follows from the design of Flood System 1 with the use Stormdry® Masonry Protection products to provide some external protection from flood water. Masonry should first be repointed to a high standard using Stormdry[®] Repointing Additive No.2. After allowing two weeks to cure, Stormdry[®] Masonry Protection Cream should be applied.

Test work demonstrates that repointing with Stormdry® Repointing Additive No.2 and applying Stormdry® Cream to a wall can greatly reduce the flow rate of water through the wall. E.g. At a flood water height of 0.6 m, the flow rate through a single skin Fletton brick wall is reduced from 12.5 litres/m²/min to less than 0.2 litres/m²/min. Stormdry[®] Cream can aid drying out of walls after flooding.

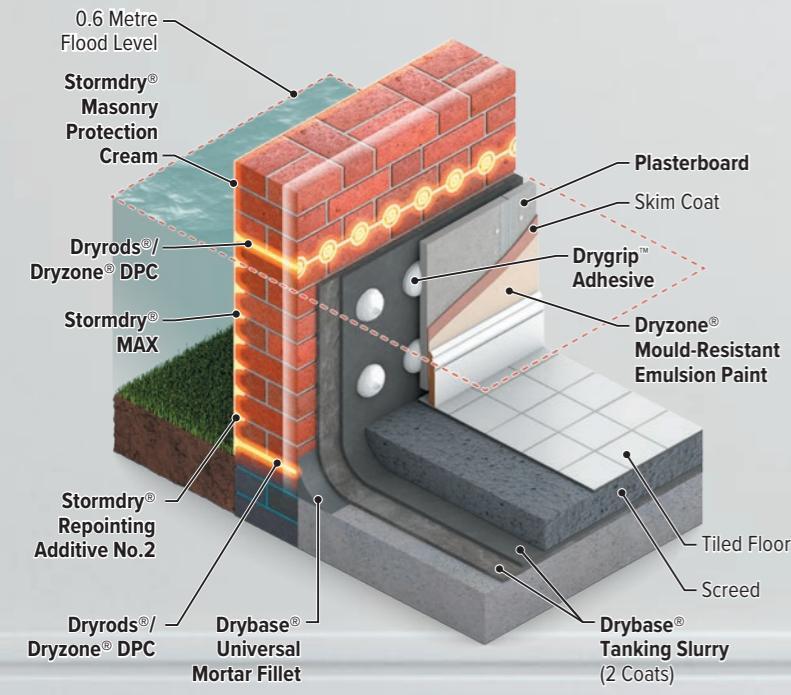
This follows on from the design of Flood System 2 with enhanced resistance from the use of Drybase® Universal Mortar and Drybase® Tanking Slurry internally. Drybase® Universal Mortar is a joint fill compound that can be used to seal the floor-wall junction, which is typically a weak point in construction, offering increased resistance to flood water. Drybase® Tanking Slurry is a cementitious tanking product that provides waterproofing at negative pressures in excess of flood design height. This can be applied up to a height of 0.6 m to seal the wall and block entry of flood water into the property. This extra layer could reduce the drying rate of the wall after a flood.
