DRYZONE[®]

TARGETED TREATMENT FOR RISING DAMP

The World's Most Rigorously Tested Rising Damp Treatment

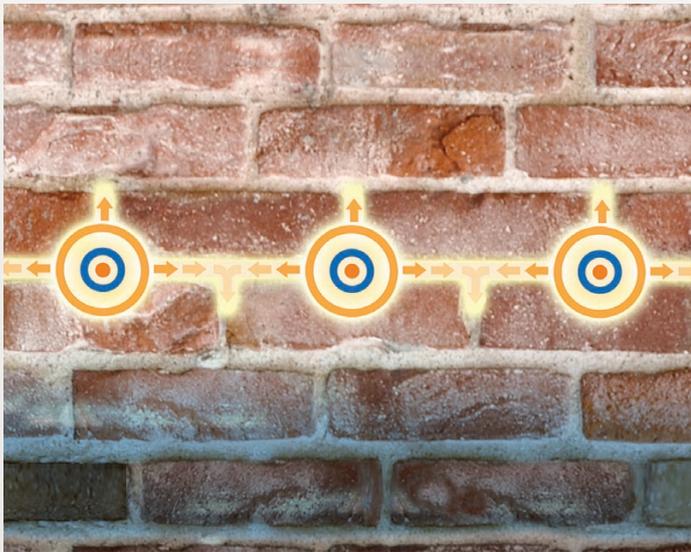
The introduction of the patented **Dryzone Damp-Proofing Cream** has revolutionised the treatment of Rising Damp. The Dryzone cream is introduced by means of a simple applicator gun into a series of holes drilled into the mortar course. Once Dryzone is installed, it diffuses to where it is most needed before curing to form a water-repellent resin.

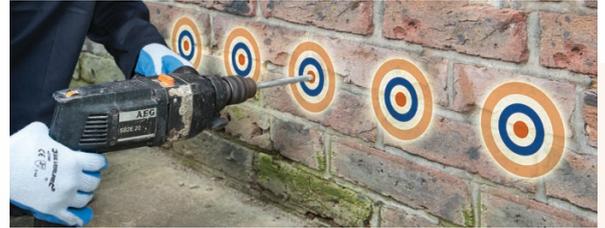
1. Drilling

First create a series of horizontal drill holes along the mortar course. Typically these are 12 mm holes at 120 mm intervals - refer to the Dryzone application instructions for details for particular wall thicknesses.

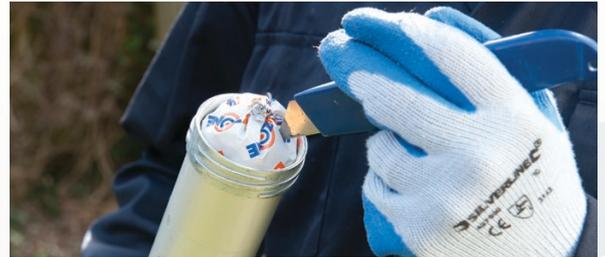
2. Preparation

Insert a Dryzone cartridge into the applicator gun, ensuring the pressure piston is fully extended. Cut into the end of the cartridge so that cream will be able to flow freely. Screw the nozzle cap back onto the gun.

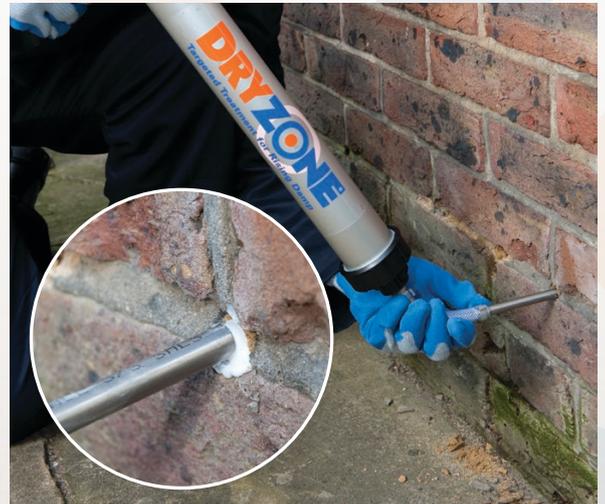
3. Injection

Fully insert the nozzle into the first drilled hole, and then inject Dryzone cream while withdrawing the nozzle at a steady rate. Stop injecting just before removing the nozzle from the wall. Repeat for remaining holes.

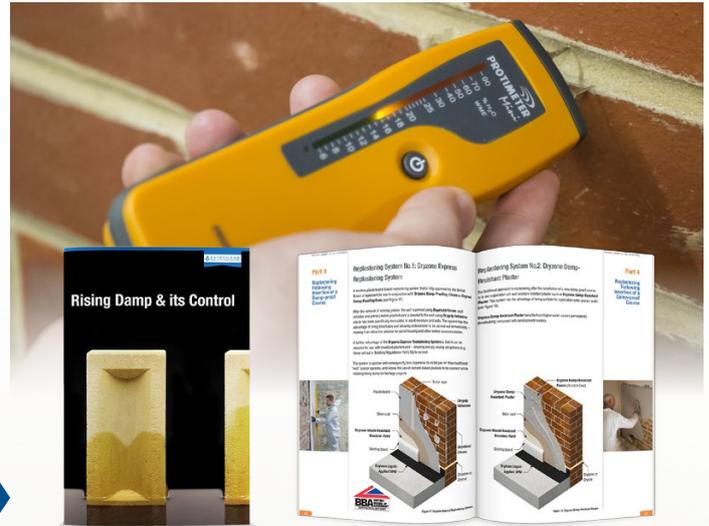
The diagram below illustrates a typical traditional replastering solution. Depending on the situation and time constraints, Safeguard recommend three replastering methods:

Install Damp-proof Course
Install the new damp-proof course using either Dryzone DPC Cream or Dryrod DPC Rods.

Apply Scratch Coat
Apply a rough coat of at least 5 mm thickness. This will act as an anchoring layer.

Apply the Plaster Coat
Once the rough coat has become firm, apply the plaster again with a thickness of at least 15 mm - 20 mm.

Finishing Coat
Apply the final skim coat using a suitable skim plaster.

Prepare the Wall
Remove damp/salt contaminated plaster.
