The World's Most Rigorously Tested Rising Damp Treatment

Quick to Install – Unrivalled Performance

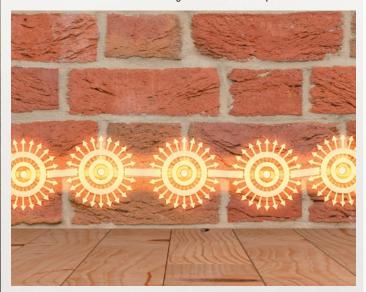
The introduction of the patented **Dryzone® Damp-Proofing Cream** has revolutionised the treatment of Rising Damp. The **Dryzone® Cream** is introduced by means of a simple applicator gun into a series of holes drilled into the mortar course. Once **Dryzone® Cream** is installed, it diffuses to where it is most needed before curing to form a water-repellent resin.
